21 PRESERVATION BRIEFS

Repairing Historic Flat Plaster—Walls and Ceilings

U.S. Department of the Interior National Park Service
Preservation Assistance Division Technical Preservation Services

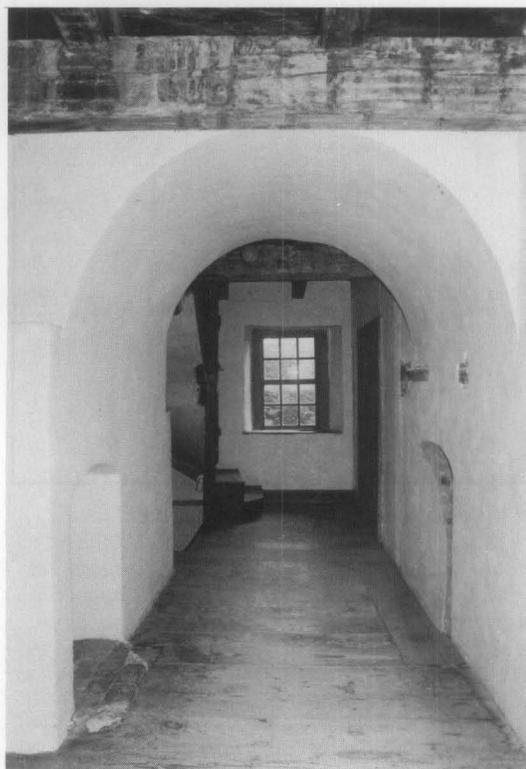
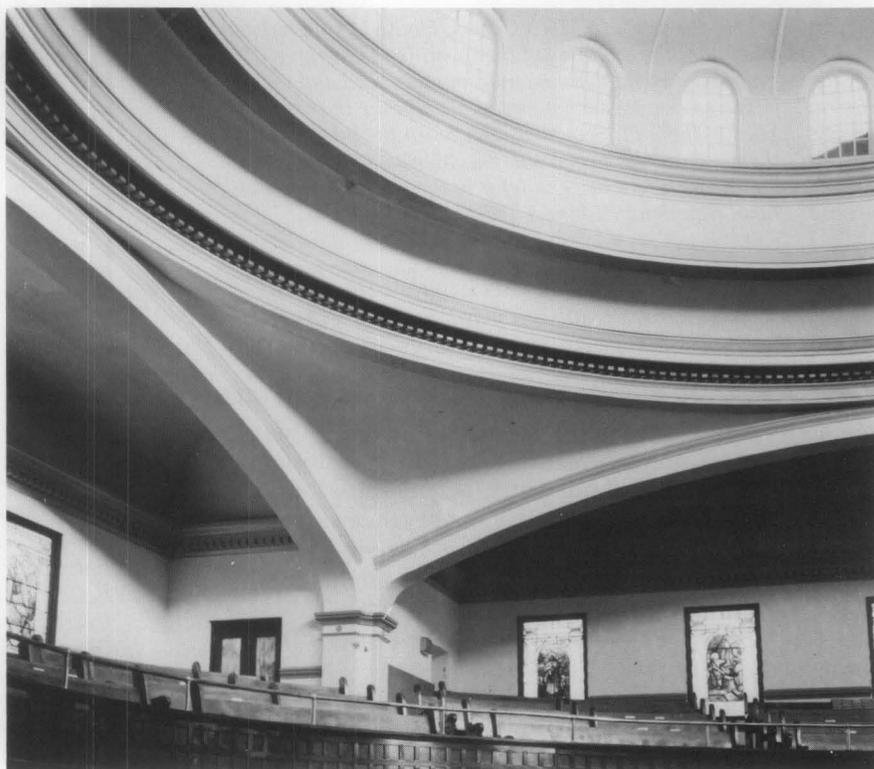
Fig. 1. Left: Schifferstadt, Frederick, Maryland, 1756. Right: First Christian Church, Eugene, Oregon, 1911. Although these two structures are separated in history by over 150 years and differences in size, ethnic origin, geography, construction techniques, and architectural character, their builders both used plaster as the interior surface coating for flat and curved walls. Photo left: Kay Weeks. Photo right: Kaye Ellen Simonson.

Plaster could be treated in any number of ways: it could receive stenciling, decorative painting, wallpaper, or whitewash. This variety and the adaptability of the material to nearly any building size, shape, or configuration meant that plaster was the wall surface chosen for nearly all buildings until the 1930s or 40s (Fig. 1).

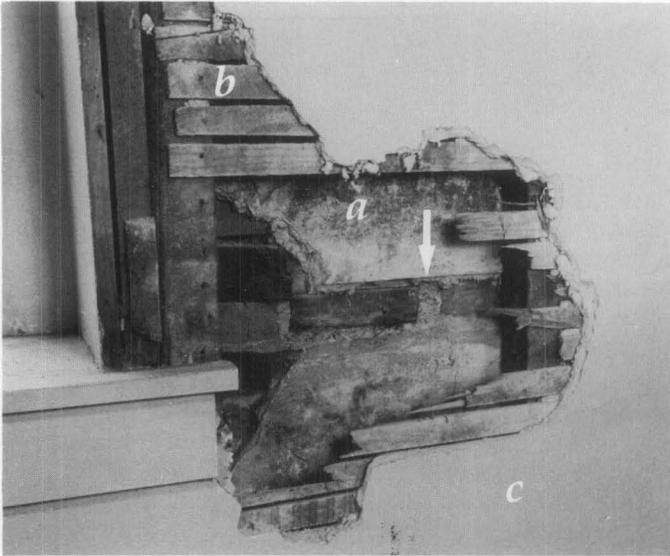
Fig. 2. A hole in the wall of a 1760s Custom House in Chestertown, Maryland illustrates the evolution of the room. (a) The original plaster was applied directly to an exterior masonry wall and the chairrail (missing here, see arrow) was in place before the wet plaster was applied to the wall. Sometime later when the interior was modified, the masonry was furred out. Machine-sawn wood lath (b) was nailed to the furring strips and (c) new three-coat plaster was applied. Photo: Maryland Historical Trust.

and durability. It resists fire and reduces sound transmission. Next, replacing plaster is expensive. A building owner needs to think carefully about the condition of the plaster that remains; plaster is often not as badly damaged as it first appears. Of more concern to preservationists, however, original lime and gypsum plaster is part of the building's historic fabric—its smooth-troweled or textured surfaces and subtle contours evoke the presence of America's earlier craftsmen. Plaster can also serve as a plain surface for irreplaceable decorative finishes. For both reasons, plaster walls and ceilings contribute to the historic character of the interior and should be left in place and repaired if at all possible (Fig. 2).

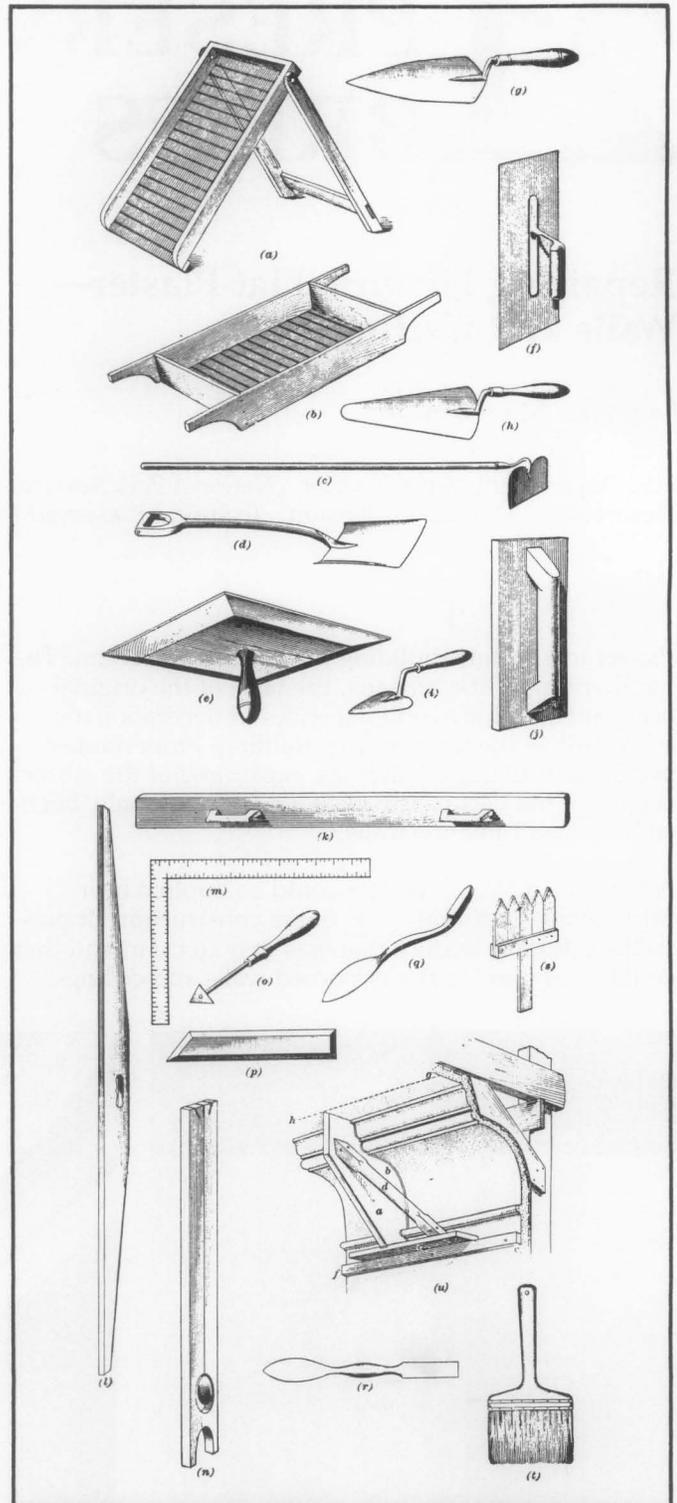
Fig. 3. Many of these traditional plastering tools are still used today: (a) screen to separate coarse sand from fine sand; (b) lime screen to remove unslaked particles of lime; (c) hoe; (d) shovel; (e) hawk to hold small amounts of plaster; (f) angle float to apply finishes to inside angles; (g), (h), (i) assorted trowels to apply base-coats and finish coat; (j) padded float to level off humps and fill in hollows caused by other tools; (k) a two-handed float or "darby" to float larger surfaces; (l) a simple straight edge; (m) a square to test the trueness of angles; (n) plumb to check verticality of plastered surfaces; (o), (p), (q), (r) jointing and mitering tools to pick out angles in decorative moldings; (s) comb made of sharpened lath pieces to scratch the basecoat of plaster; (t) brush to dampen plaster surfaces while they are worked smooth; (u) template made of wood and metal to cut a required outline for a fancy mold.

To repair plaster, a building owner must often enlist the help of a plasterer. Plastering is a skilled craft, requiring years of training and special tools (Fig. 3). While minor repairs can be undertaken by building owners, most repairs will require the assistance of a plasterer.

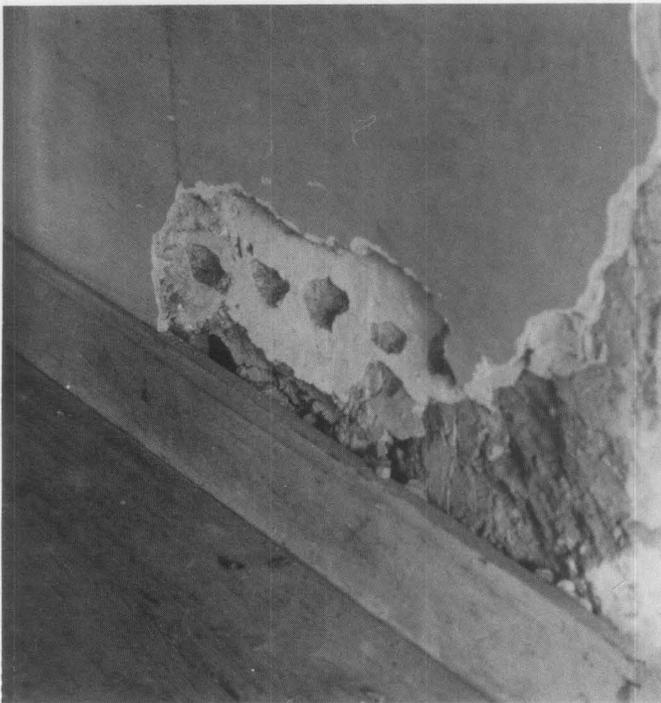
Fig. 4. The builders of this mid-18th century house installed the baseboard moulding first, then applied a mud and horse hair plaster (called *paling*) to the masonry wall. Lime was used for the finish plaster. Also shown are the hacking marks which prepared the wall for a subsequent layer of plaster. Photo: Kay Weeks.

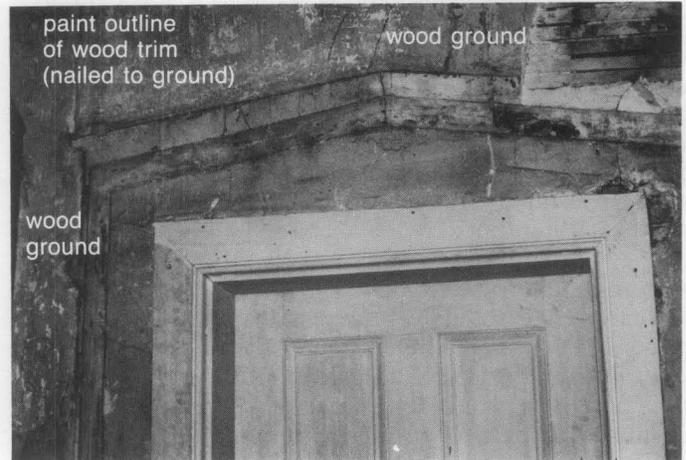
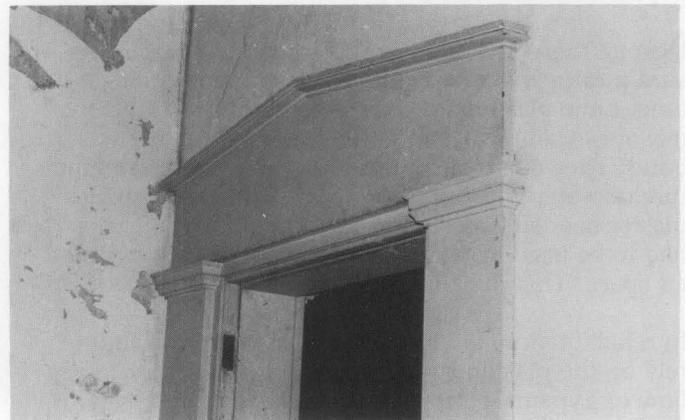
Fig. 5 (a). The photo above shows the use of wooden plaster "grounds" nailed to the wall studs of the mid-19th century Lockwood House in Harpers Ferry, West Virginia. This allowed the plasterer to work flush with the surface of the grounds. Afterwards, the carpenter could nail the finish woodwork to the ground, effectively hiding the joint between the plaster and the ground. The trim was painted after its installation, leaving a paint outline on the plaster. Fig. 5 (b). The photo below shows door trim and mouldings in place after the plastering was complete. Photos: Kaye Ellen Simonson.

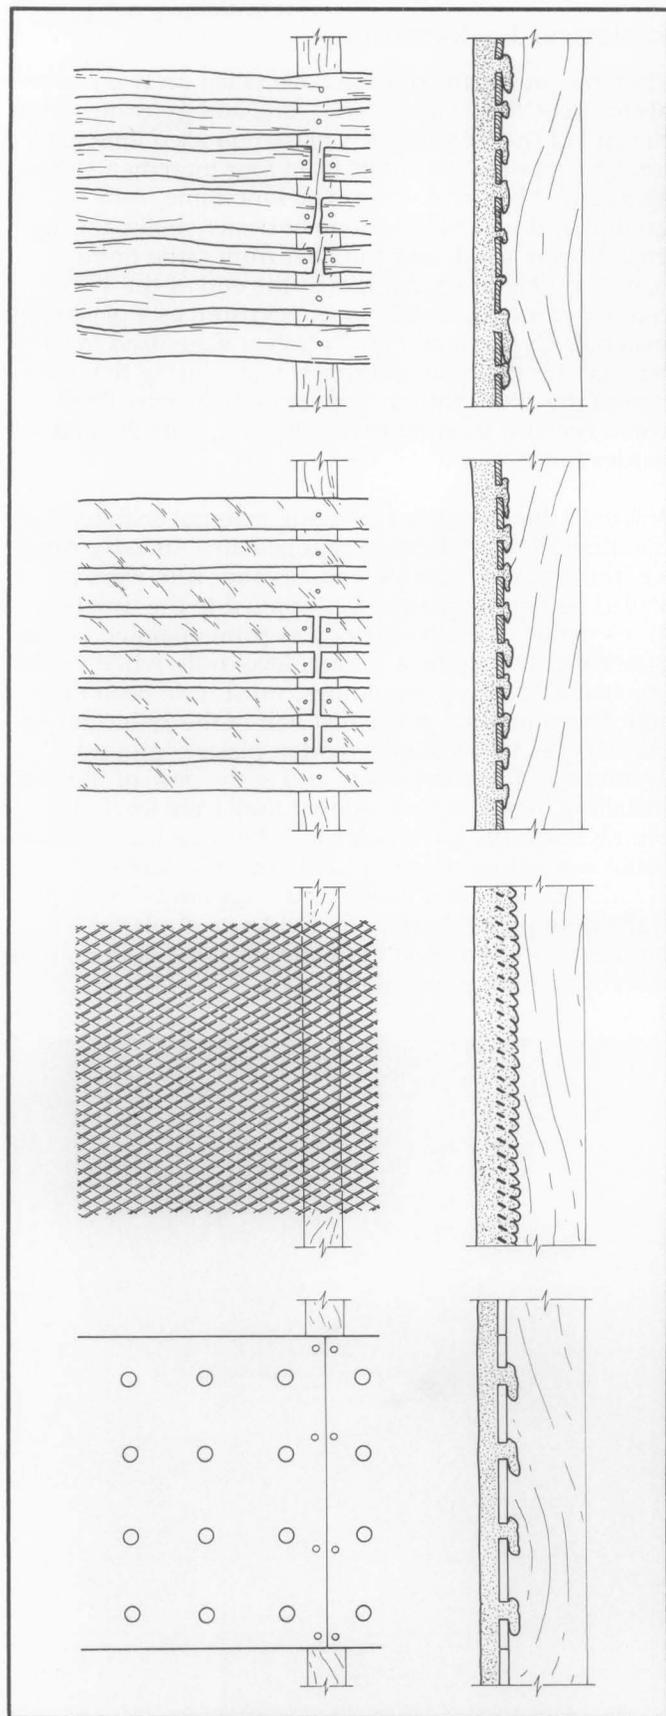
Fig. 6. Top to bottom: Hand-riven lath, machine-sawn wood lath, expanded metal (diamond mesh) lath, and perforated gypsum board lath. Profile views of their keying characteristics are shown to the right. For plaster repairs or replastering, galvanized metal lath is the most reliable in terms of longevity, stability, and proper keying. Drawing: Kaye Ellen Simonson.

Lath provided a means of holding the plaster in place. Wooden lath was nailed at right angles directly to the structural members of the buildings (the joists and studs), or it was fastened to non-structural spaced strips known as furring strips. Three types of lath can be found on historic buildings (Fig. 6).

Wood Lath. Wood lath is usually made up of narrow, thin strips of wood with spaces in between. The plasterer applies a slight pressure to push the wet plaster through the spaces. The plaster slumps down on the inside of the wall, forming plaster "keys." These keys hold the plaster in place.

Metal Lath. Metal lath, patented in England in 1797, began to be used in parts of the United States toward the end of the 19th century. The steel making up the metal lath contained many more spaces than wood lath had contained. These spaces increased the number of keys; metal lath was better able to hold plaster than wood lath had been.

Rock Lath. A third lath system commonly used was rock lath (also called plaster board or gypsum-board lath). In use as early as 1900, rock lath was made up of compressed gypsum covered by a paper facing. Some rock lath was textured or perforated to provide a key for wet plaster. A special paper with gypsum crystals in it provides the key for rock lath used today; when wet plaster is applied to the surface, a crystalline bond is achieved.

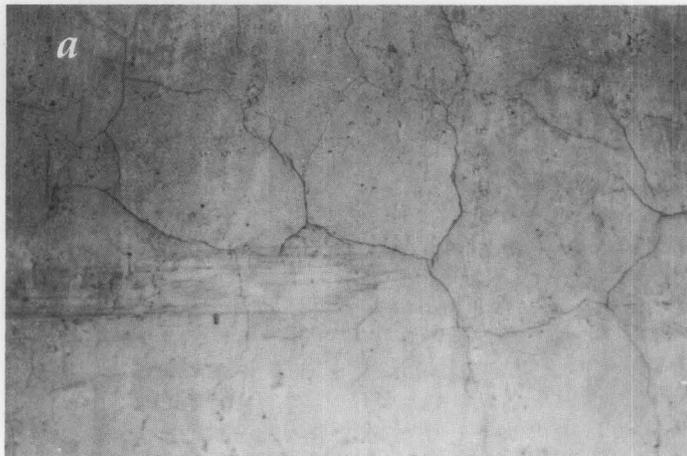
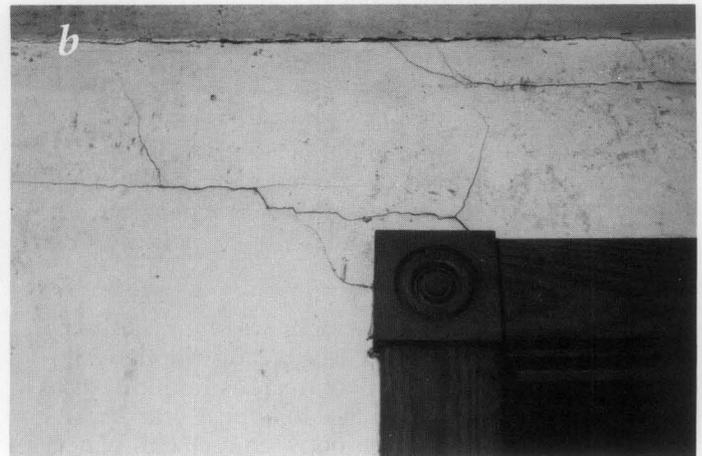
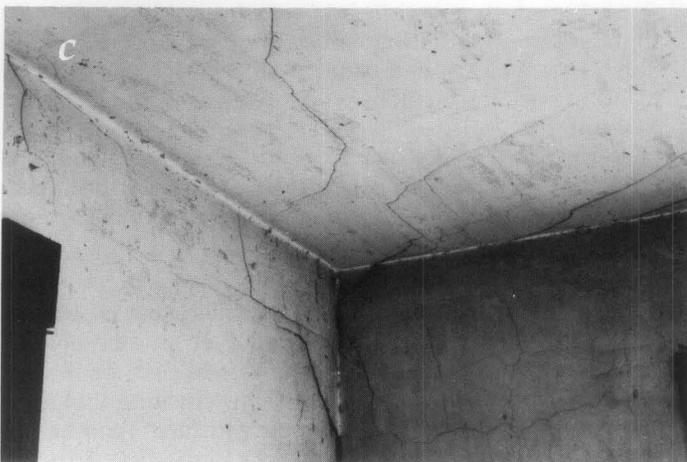
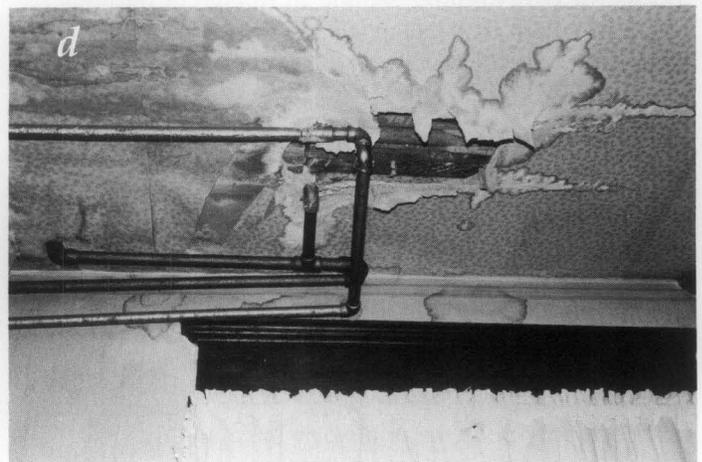
Fig. 7 (a) to (d). A series of photographs taken in different rooms of an early 20th century house in West Virginia reveal a variety of plaster wall surface problems, most of which can easily be remedied through sensitive repair: Hairline cracks (a) in an otherwise sound wall can be filled with joint compound or patching plaster. The wall can also be canvassed or wallpapered. Stress cracks (b) in plaster over a kitchen door frame can be repaired using fiberglass mesh tape and joint compound. Settlement cracks (c) in a bedroom can be similarly repaired. The dark crack at the juncture between walls, however, may be a structural crack and should be investigated for its underlying cause. Moisture damage (d) from leaking plumbing on the second floor has damaged both wallpaper and plaster in the dining room. After fixing the leaking pipes, the wall covering and rotted plaster will need to be replaced and any holes repaired. Photos: Kay Weeks.

When plaster dries, it is a relatively rigid material which should last almost indefinitely. However, there are conditions that cause plaster to crack, effloresce, separate, or become detached from its lath framework (Fig. 7). These include:

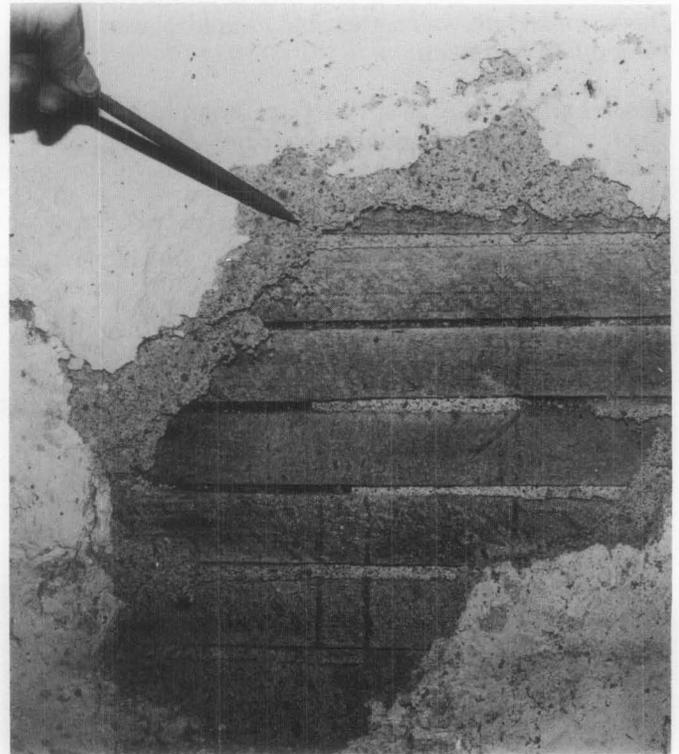
Fig. 8. Too much aggregate (sand) and not enough cementing material (lime or gypsum) in the base coat has made this plaster surface weak and crumbly. Besides losing its key with the lath, the layers are disintegrating. It will most likely need to be totally removed and replaced with all new plaster. Photo: Marylee MacDonald.

cheaper material. Oversanding can cause the plaster to weaken or crumble (Fig. 8). Plaster made from a poorly proportioned mix may be more difficult to repair.

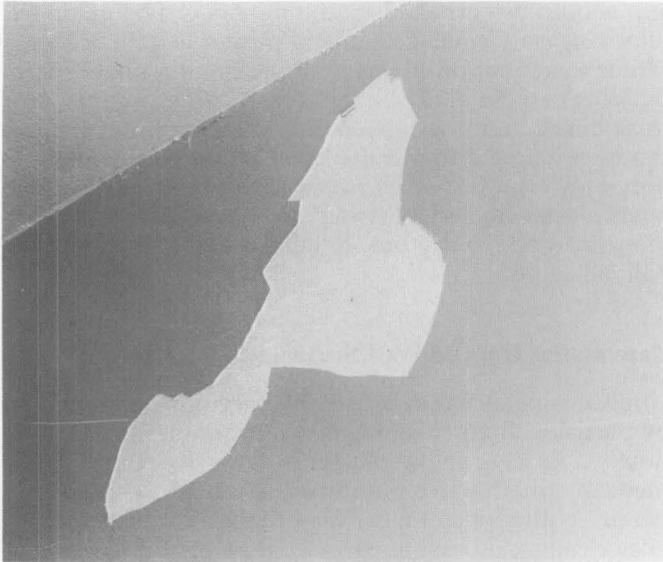
Fig. 9. The smooth-troweled lime finish coat has delaminated from the brown coat underneath. This is another repair that can be undertaken without further loss of the historic plaster. Photo: Marylee MacDonald.

Sometimes the finish coat of plaster comes loose from the base coat (Fig. 9). In making this type of repair, the plasterer paints a liquid plaster-bonding agent onto the areas of base-coat plaster that will be replastered with a new lime finish coat. A homeowner wishing to repair small areas of delaminated finish coat can use the methods described in **Patching Materials**.

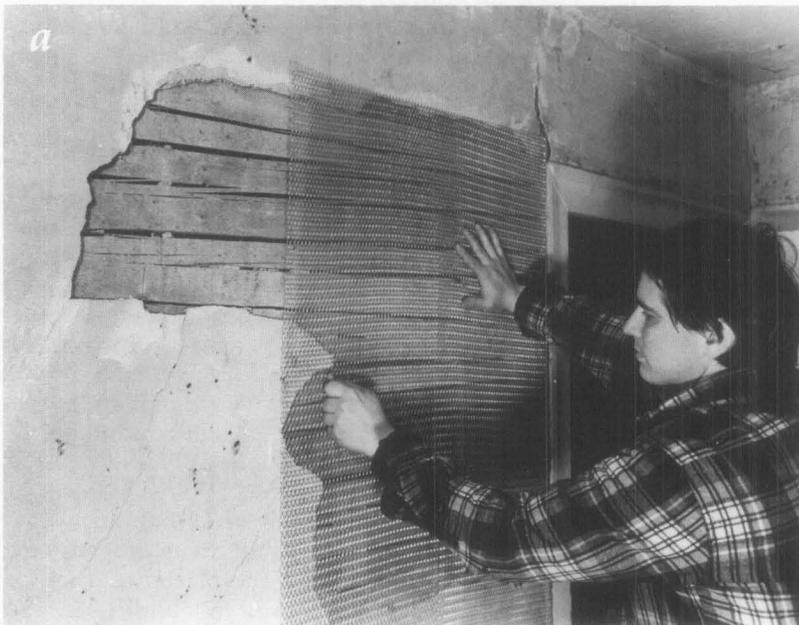
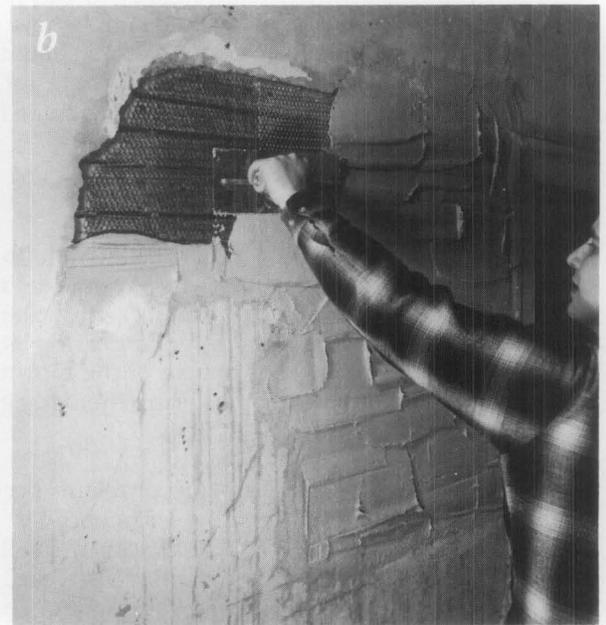
Fig. 10 (a) and (b). In this New Hampshire residence dating from the 1790s, the original plaster was a single coat of lime, sand, and horsehair applied over split lath. A one-coat repair, in this case, is appropriate. To the left: a flat sheet of galvanized expanded metal lath is placed over the patch area and an outline marked with a large soft lumber crayon. The metal lath is then cut to fit the hole and nailed to the lath. To the right: the edges of the original plaster and wood lath beneath have been thoroughly soaked with water. A steel trowel is used to apply the plaster in large, rough strokes. Finally, it will be scraped and smoothed off. Because only one coat of plaster is used, without a finish coat, a clean butt-joint is made with the original plaster. Photos: John Leeke.

For small holes (less than 4 inches in diameter) that involve loss of the brown and finish coats, the repair is made in two applications. First, a layer of basecoat plaster is troweled in place and scraped back below the level of the existing plaster. When the base coat has set but not dried, more plaster is applied to create a smooth, level surface. One-coat patching is not generally recommended by plasterers because it tends to produce concave surfaces that show up when the work is painted. Of course, if the lath only had one coat of plaster originally, then a one-coat patch is appropriate (Fig. 10).

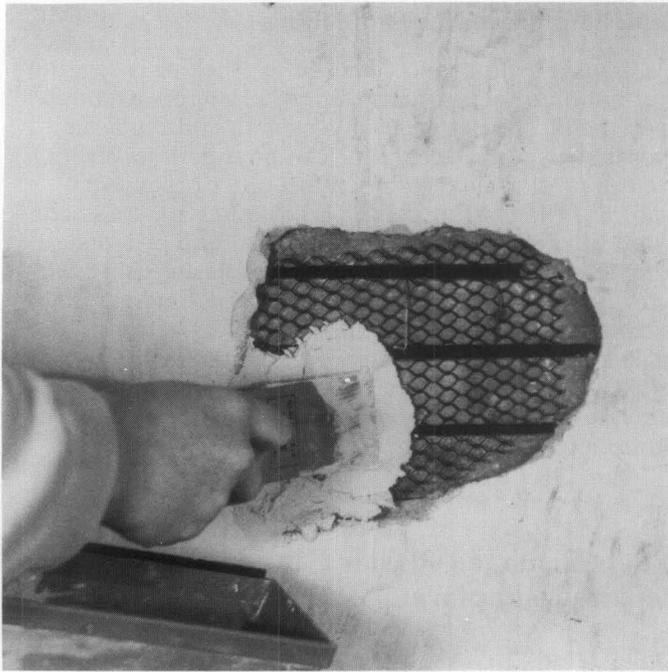
Fig. 11. Repairs are being made to the historic plaster in an early 20th century residence in Tennessee. A fairly sizeable hole in three-coat plaster extends to the wood lath. Expanded metal lath has been cut to fit the hole, then attached to the wood lath with a tie-wire. Two ready-mix gypsum base coats are in the process of being applied. After they set, the finish coat will be smooth-troweled gauged lime to match the existing wall. Photo: Walter Jowers.

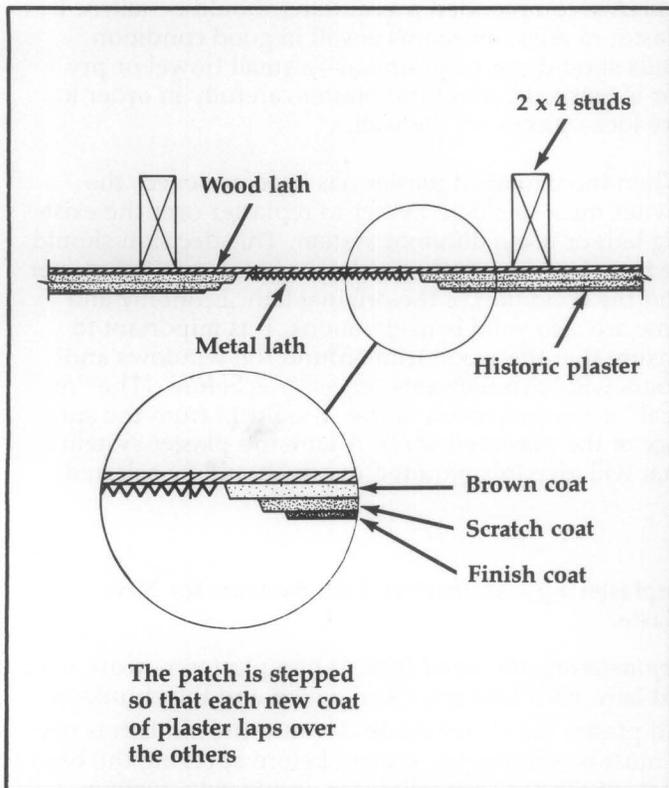
Fig. 12. This explains how a hole in historic plaster is repaired over the existing wood lath. First, metal lath is secured over the wood lath with a tie wire, then the new plaster is applied in three layers, "stepped" so that each new coat overlaps the old plaster to create a good adhesive bond. Drawing: Kaye Ellen Simonson.

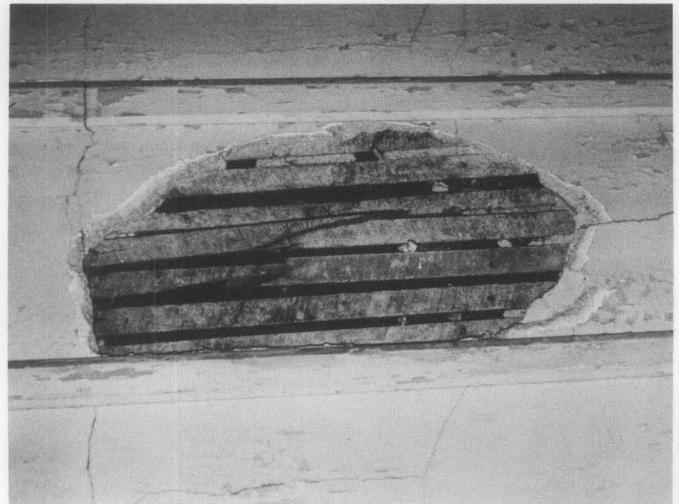
Fig. 13. This beaded ceiling in one of the bedrooms of the 1847 Lockwood House, Harpers Ferry, West Virginia, is missing portions of plaster due to broken keys. This is attributable, in part, to deterioration of the wood lath. Photo: Kaye Ellen Simonson.

Hairline cracks and holes may be unsightly, but when portions of the ceiling come loose, a more serious problem exists (Fig. 13). The keys holding the plaster to the ceiling have probably broken. First, the plaster around the loose plaster should be examined. Keys may have deteriorated because of a localized moisture problem, poor quality plaster, or structural overloading; yet, the surrounding system may be intact. If the areas surrounding the loose area are in reasonably good condition, the loose plaster can be reattached to the lath using flat-head wood screws and plaster washers (Fig. 14). To patch a hole in the ceiling plaster, metal lath is fastened over the wood lath; then the hole is filled with successive layers of plaster, as described above.

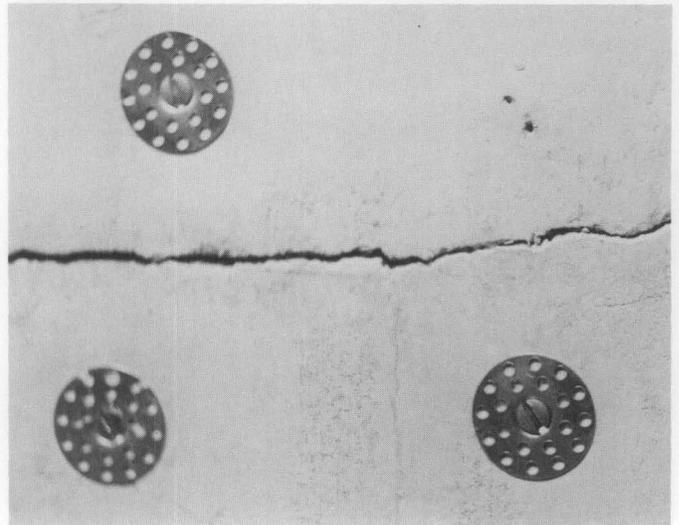
Fig. 14. In a late 18th century house in Massachusetts, flat-head wood screws and plaster washers were used to reattach loose ceiling plaster to the wood lath. After the crack is covered with fiberglass mesh tape, both the taped crack and the plaster washers will be skim-coated with a patching material. Photo: John Obed Curtis.

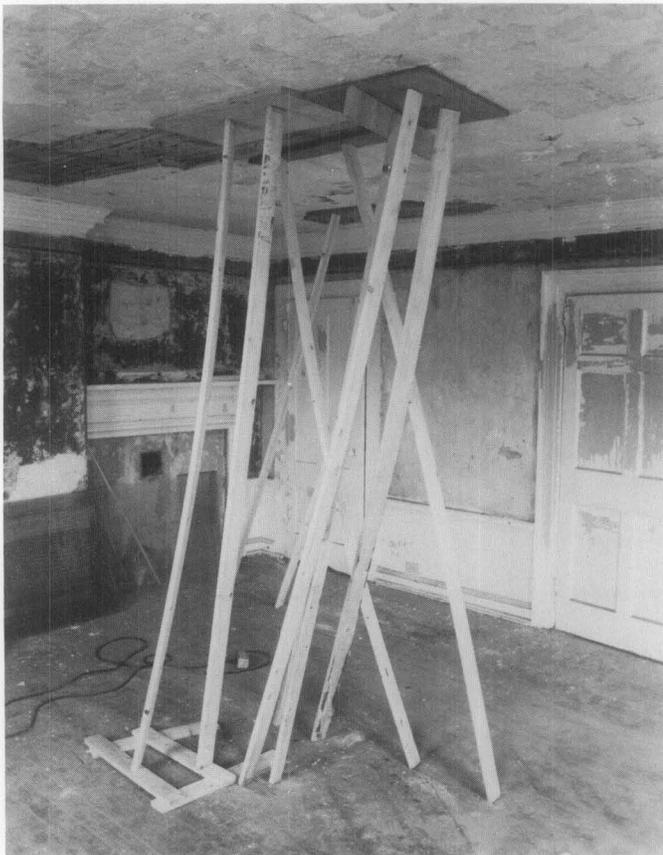
Fig. 15. When ceiling repairs are made with wet plaster or with an injected adhesive mixture, the old loose plaster must be supported with a plywood brace until re-keying is complete. Photo: John Leeke.

Loose, damaged plaster can also be re-keyed when the goal is to conserve decorative surfaces or wallpaper. Large areas of ceilings and walls can be saved. This method requires the assistance of a skilled conservator—it is not a repair technique used by most plasterers. The conservator injects an acrylic adhesive mixture through holes drilled in the face of the plaster (or through the lath from behind, when accessible). The loose plaster is held firm with plywood bracing until the adhesive bonding mixture sets. When complete, gaps between the plaster and lath are filled, and the loose plaster is secure (Fig. 15).

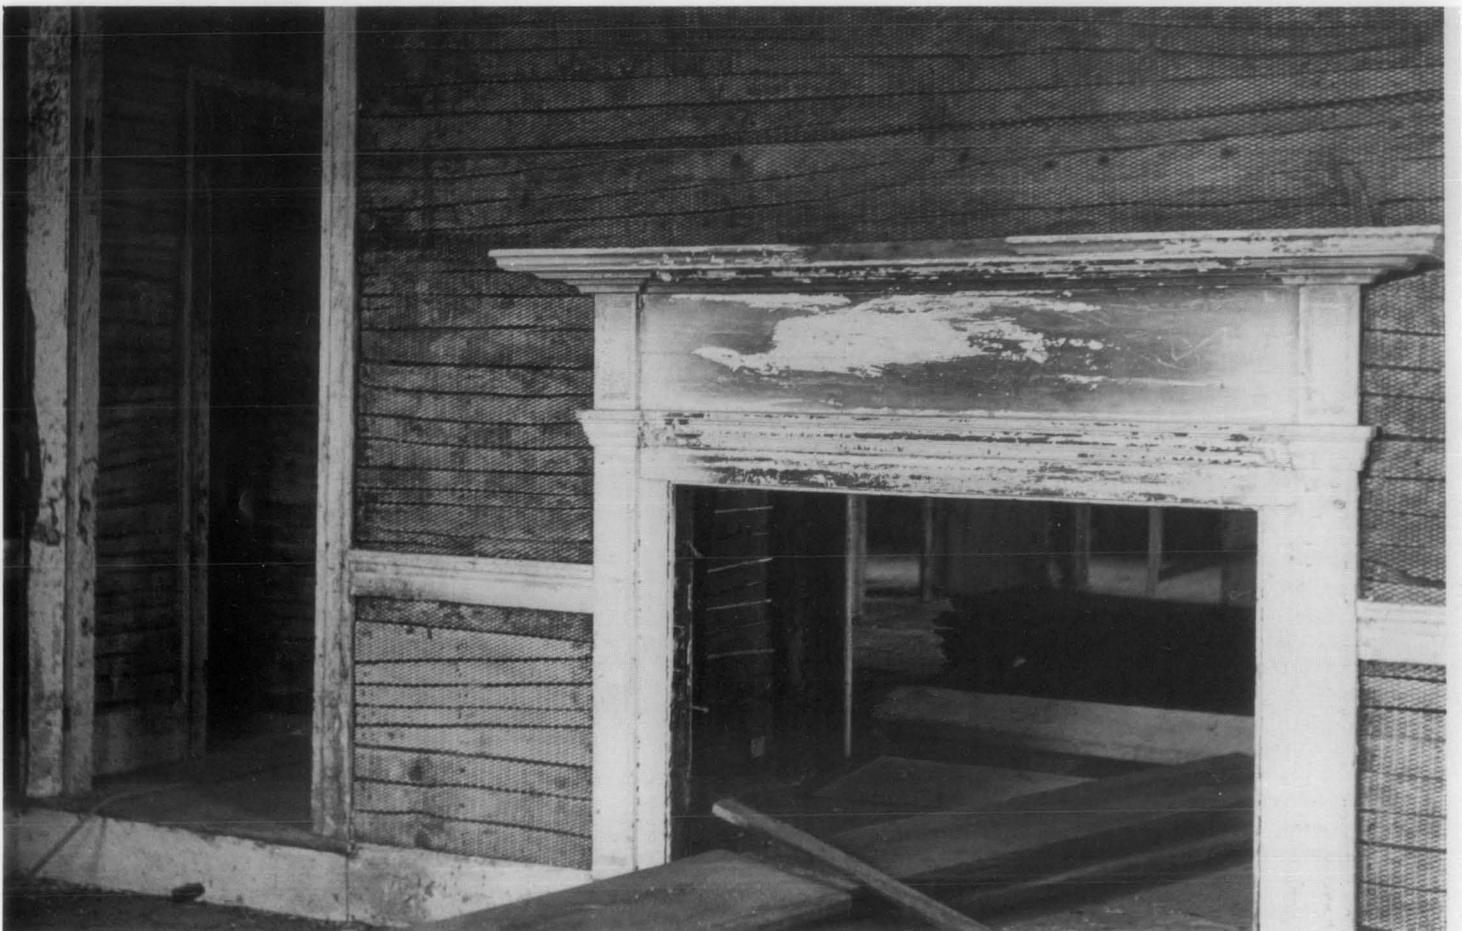
Fig. 16. In the restoration of a ca. 1830s house in Maine, split-board lath has been covered with expanded metal lath in preparation for new coats of plaster. This method permits the early lath to be saved while the metal lath, with its superior keying, serves as reinforcement. Photo: National Park Service files.
